Limited Visual Dam Safety Inspection Summary Report

MA-056

Hanakao Reservoir

Limited Visual Dam Safety Inspection Conducted on: 04 April 2006

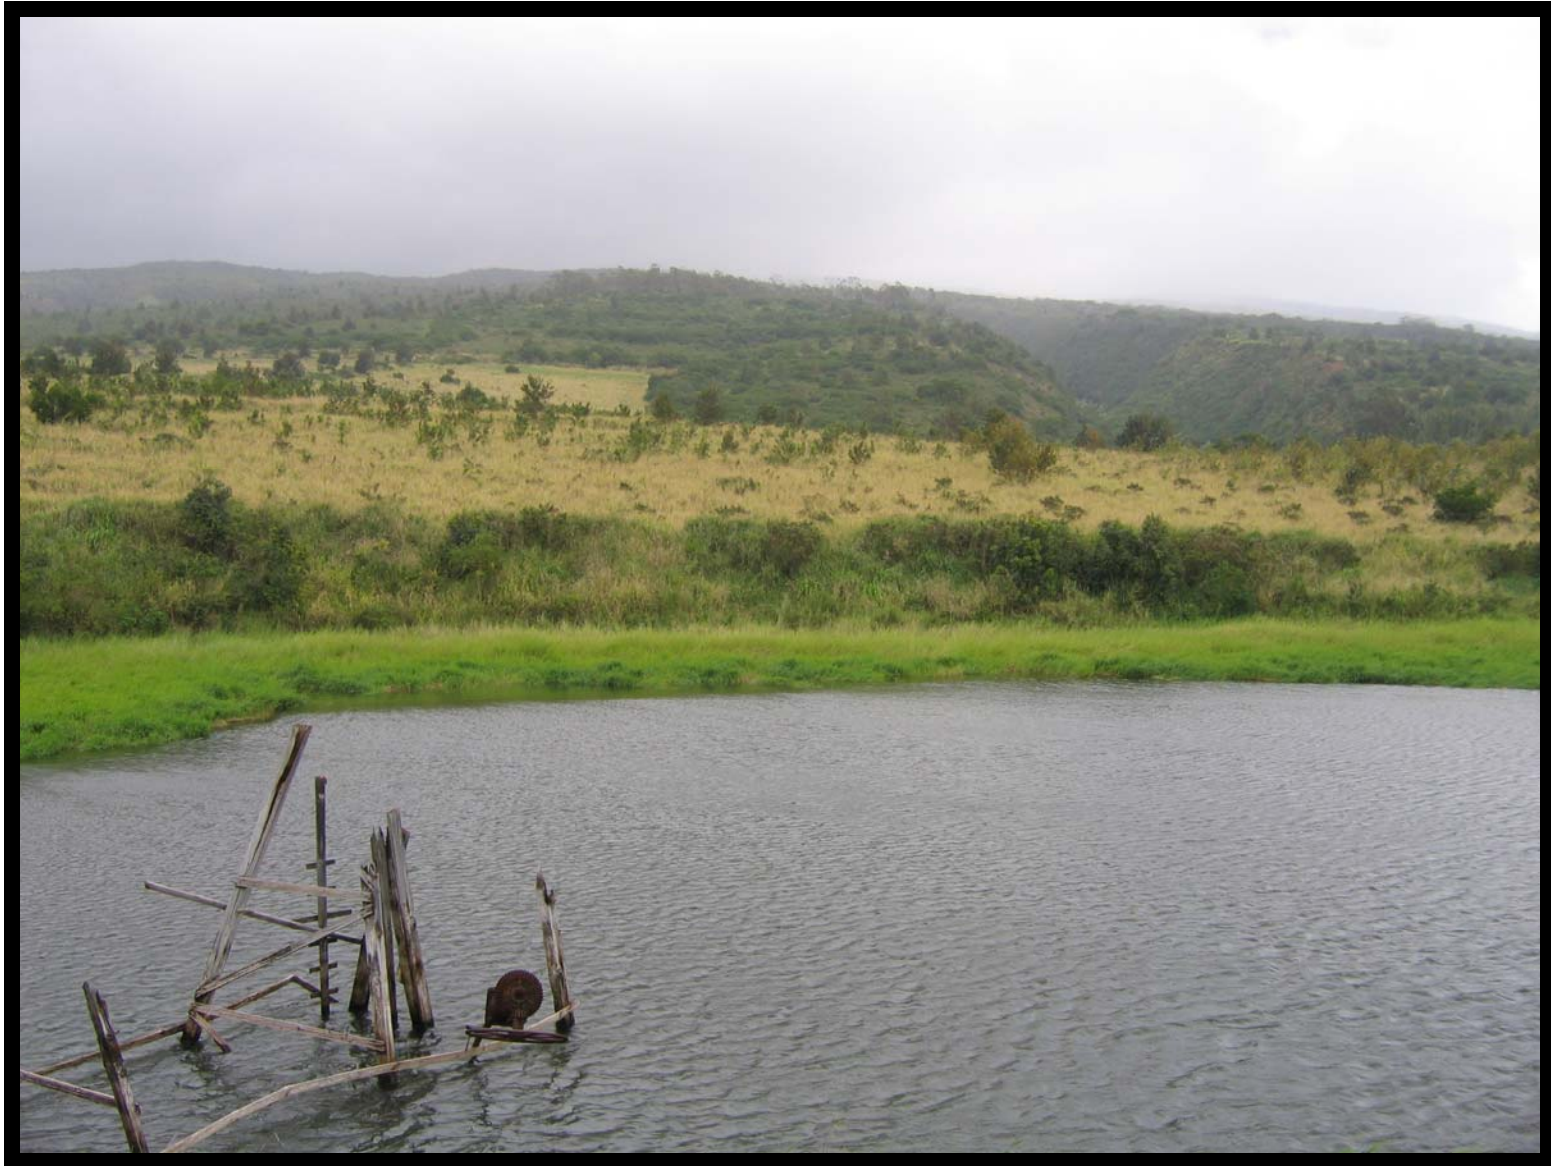
- a. The reservoir appeared to be in fair condition and requires corrective action due to heavy vegetation and it being silted in.
- b. A staff gage was not observed at the reservoir. Provide some method of quantifying the water level within the reservoir.

056 Upstream view of reservoir looking from crest.

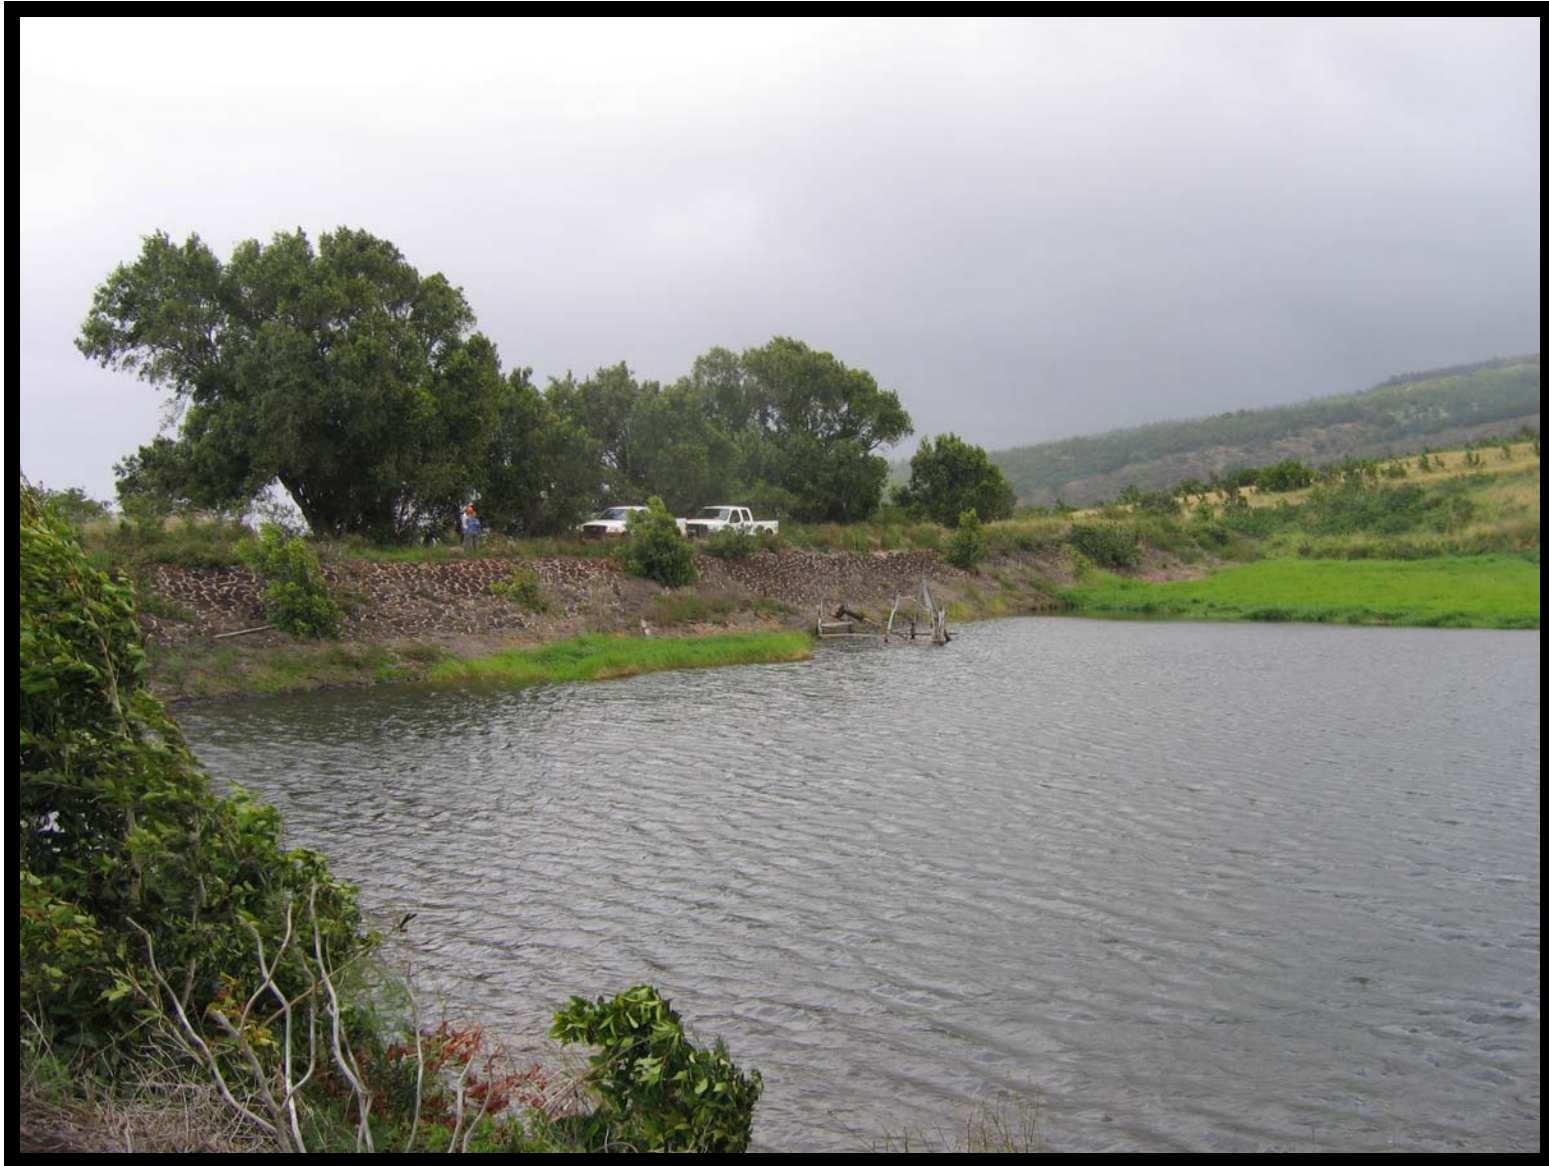
- a. The dam crest appeared to be in fair to poor condition and requires corrective action.
- b. Access along the crest was satisfactory.
- c. Portions of the crest were not visible due to high grass and bush vegetation. Clear high vegetation and maintain low to enable easy visual inspection.

056 Downstream view of crest - View of crest and reported inlet area on right end of reservoir (inaccessible).

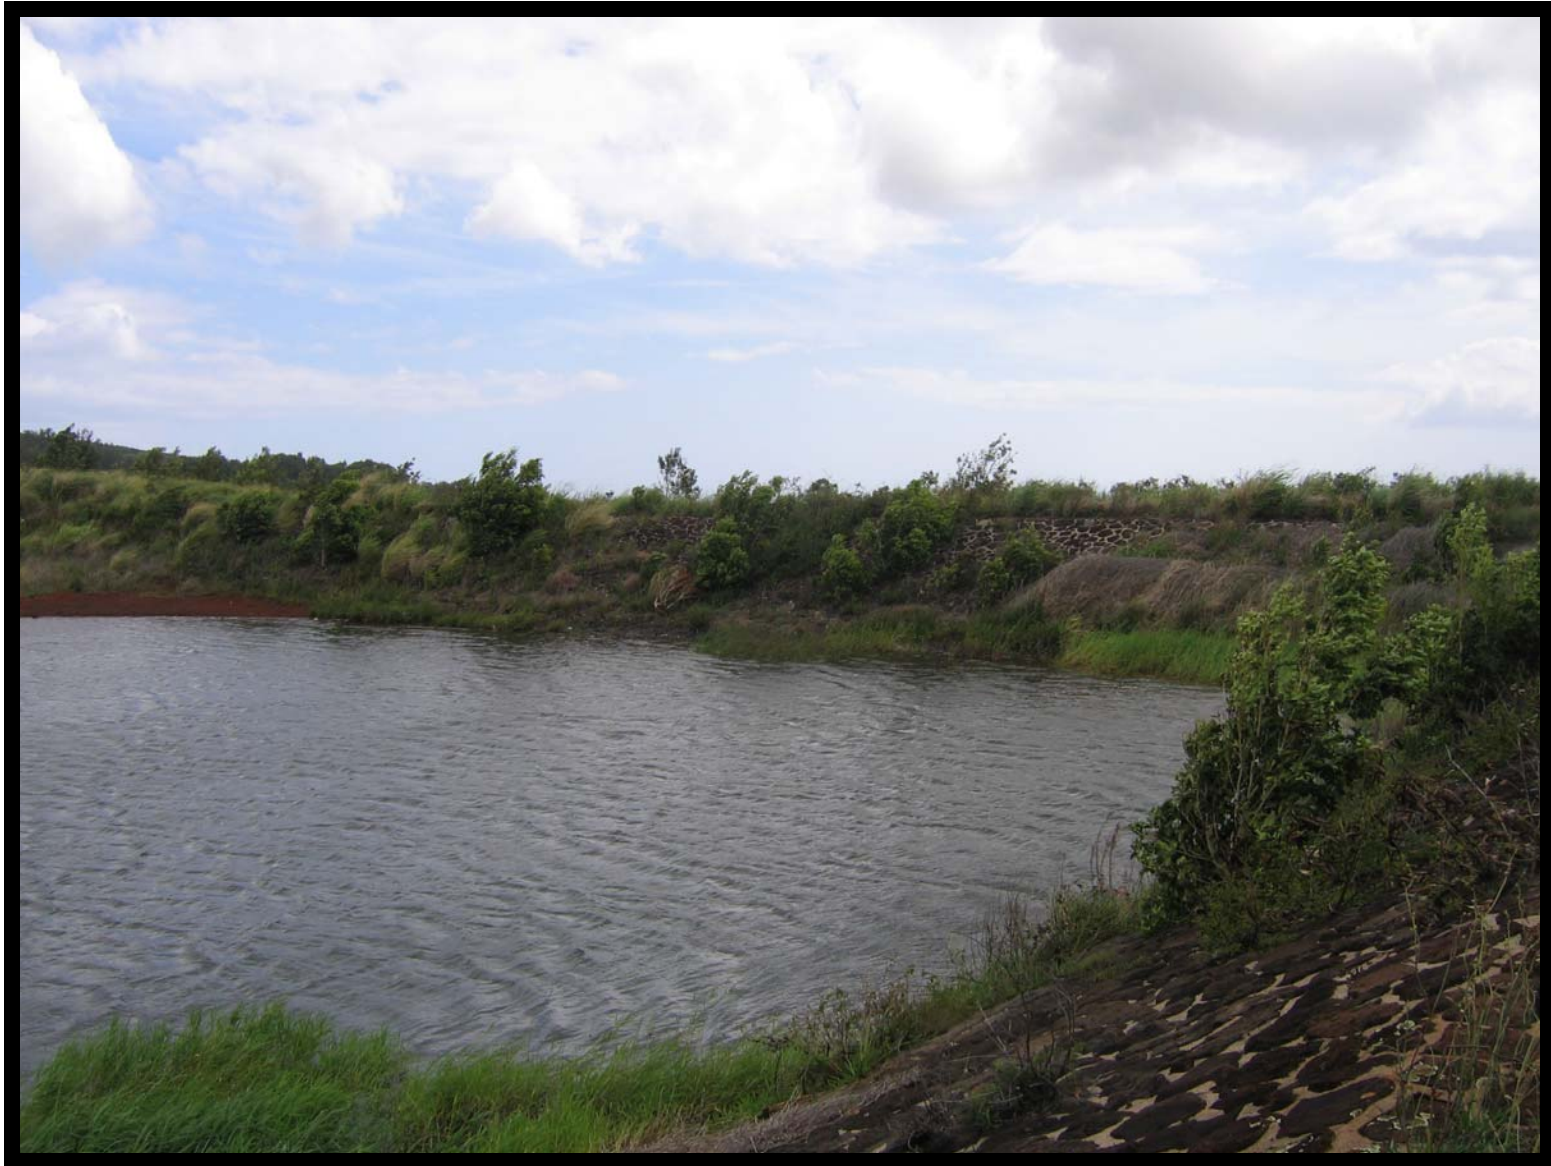
- a. The upstream slope appeared to be in satisfactory condition, no corrective actions are required at this time.
- b. Slope protection needs maintenance or repair. Remove bushes.

056 View of left side upslope from crest.

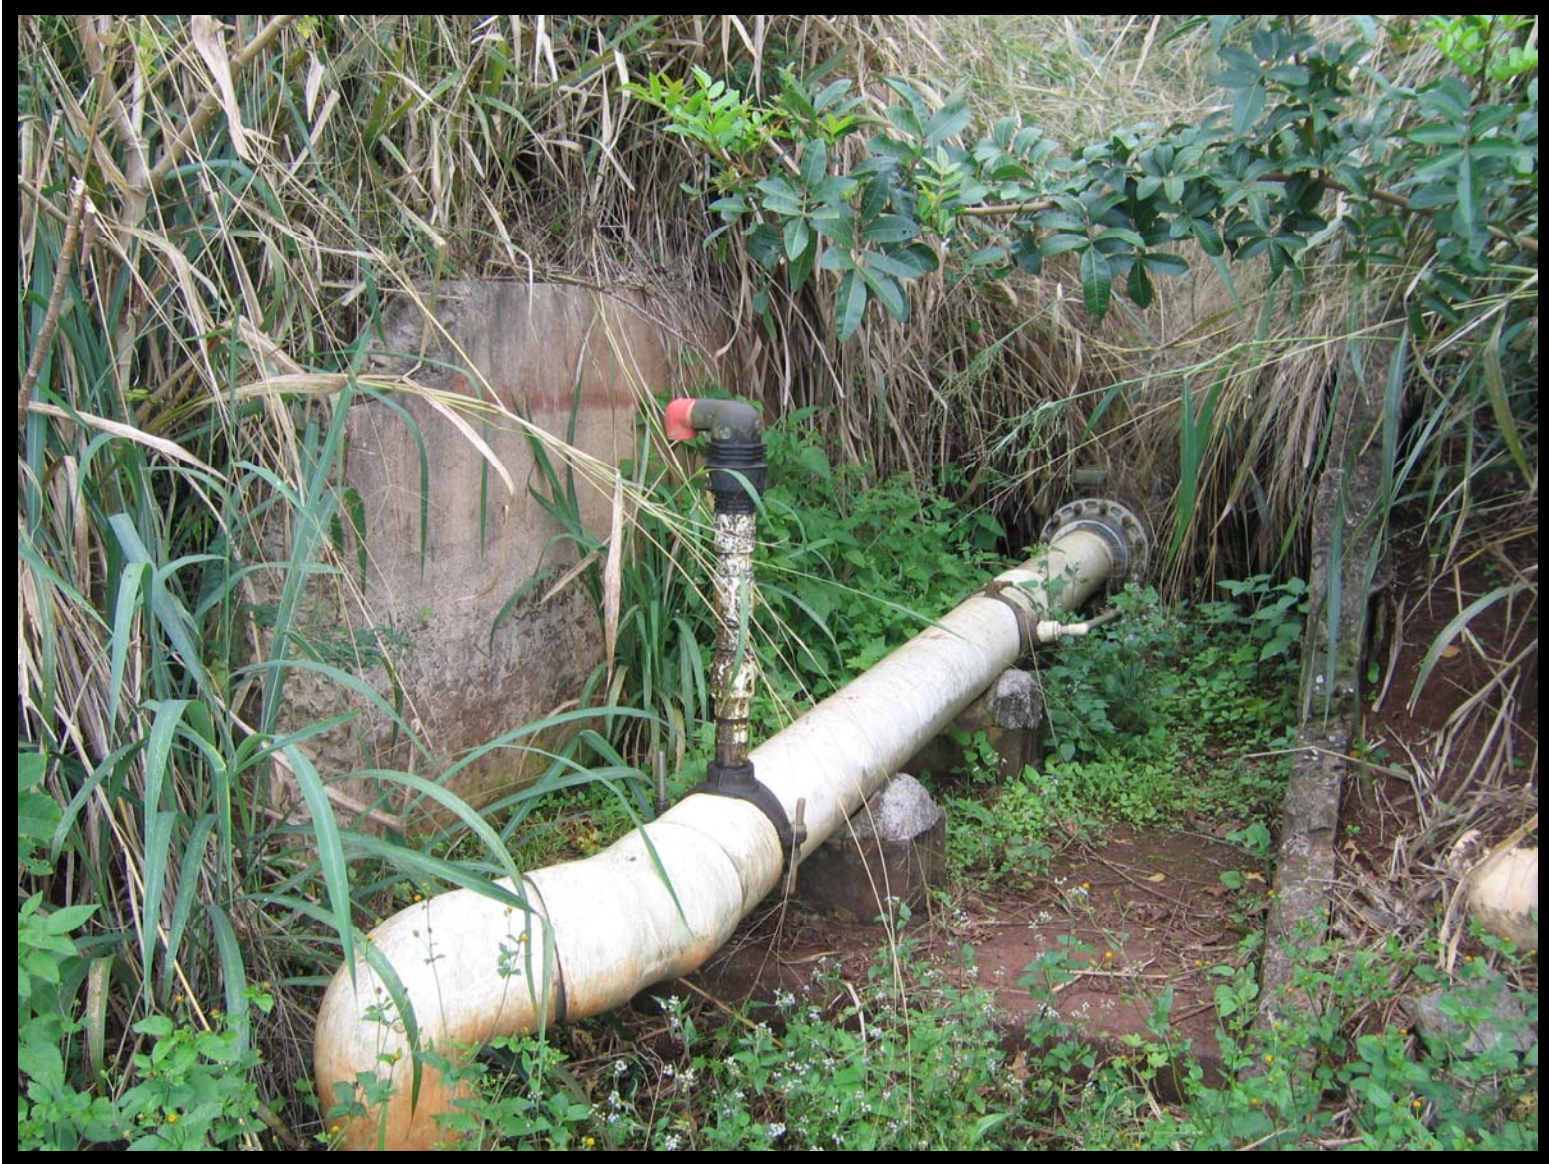
The outlet works consisted of a 12" diameter PVC siphon pipe. The outlet works control was located on the downstream side by a valve. This modification was made after the nearby Horner Dam failure in 1988.

- a. The outlet works were not tested.
- b. The outlet works appeared to be in satisfactory condition, no corrective actions are required at this time.
- c. PVC modification approximately 18 years ago.

056 PVC slip modification leading out of old DIP outlet. (12-inch dia.)

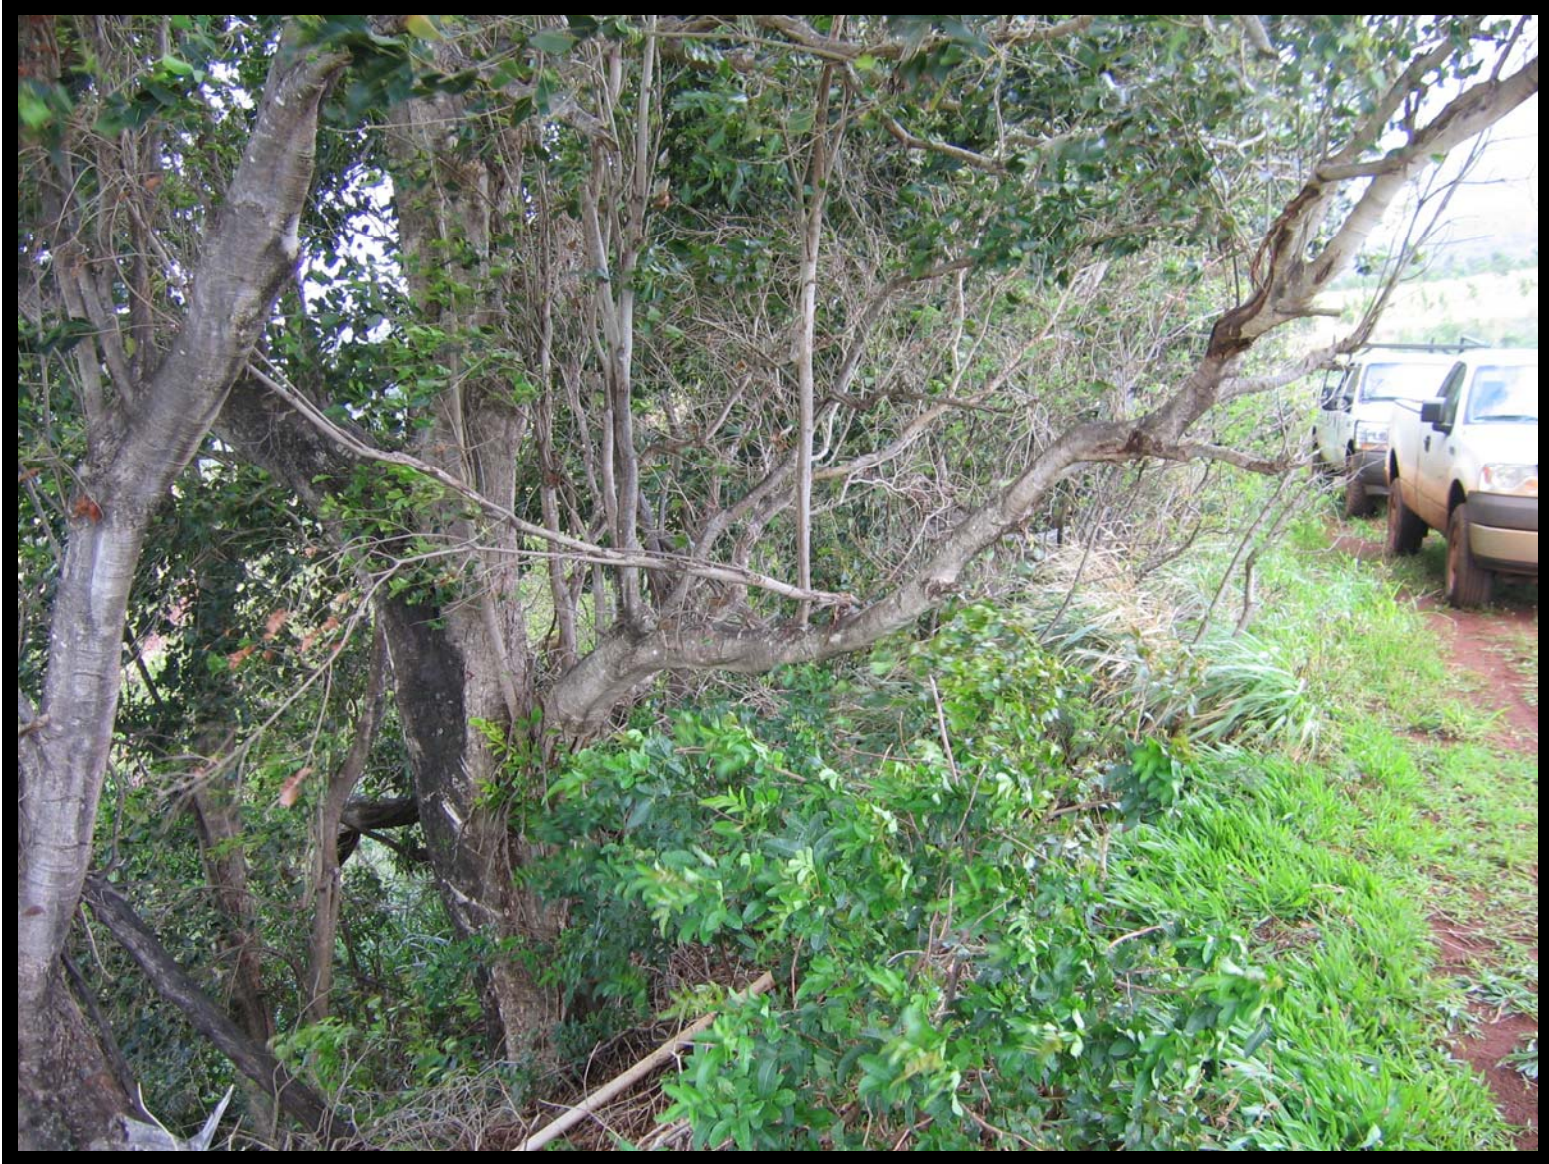
- a. The downstream slope appeared to be in fair to poor condition and requires corrective action.
- b. The downstream slope was not visible due to high grass and bush vegetation. Clear high vegetation and maintain low to enable easy visual inspection.
- c. Tree(s) were observed on the downstream slope. Trees have been identified as the probable cause of piping failures, and can possibly cause severe damage to

056 Tree Growth at Crest - Massive tree growth on crest and down slope.

the embankment if they are uprooted during high winds. Corrective action is required to remove tree hazards from the dam. Acceptable remedies include removal of the tree and its root structure down to a 2" diameter and reconstructing the damaged embankment section. All repair work shall be accomplished as per the requirements of licensed geotechnical or structural engineer. Routinely monitor the damaged area for signs of settlement and seepage.
